United States Department of the Interior

BUREAU OF LAND MANAGEMENT
Mount Lewis Field Office
50 Bastian Road
Battle Mountain, Nevada 89820
Phone: 775-635-4000; Fax: 775-635-4034
www.blm.gov/nv/

I am writing in regards to the range improvements located within the Buffalo Valley and South Buffalo allotments (jointly referred to as the Buffalo Valley Allotment). As you are well aware, a portion of the Animal Unit Months (AUM's) for the allotment are currently in temporary suspension due to non-functioning water developments within the allotment. Approximately 88 AUM's per water development will be returned to active use as improvements are repaired to BLM standards. To date 10 of the 35 identified water developments have been inspected. The following is a discussion of the findings of those inspections.

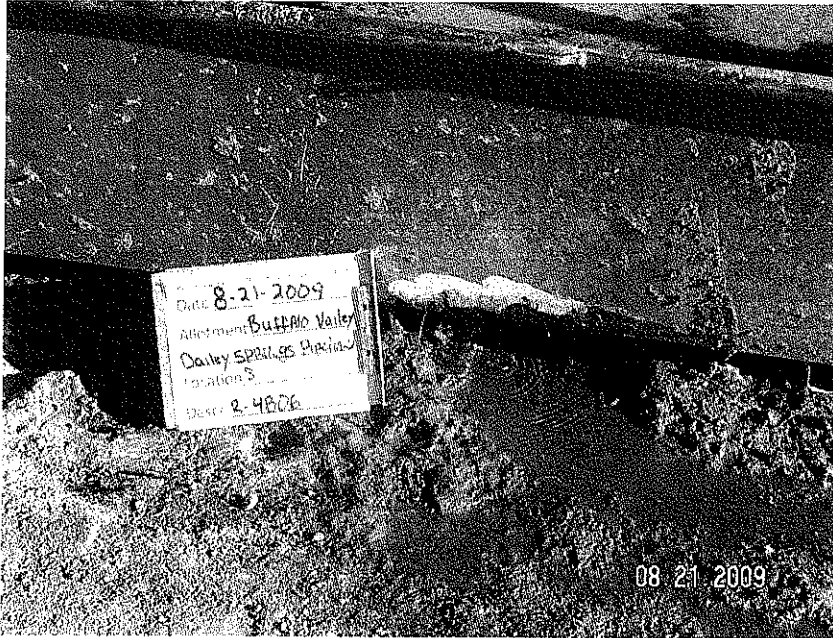
Dailey Canyon Pipe Line

Leak on Trough 2

1. Dailey Canyon Pipeline: There is a substantial leak in trough 2 which needs to be repaired or the trough needs to be replaced. Trough 1 needs to have a bird ladder installed.
2. Bluelead Pipeline: Bird ladders need to be installed on all three troughs and trough 3 needs to be leveled.
3. Nancy Spring: A section of pipe directly below the spring enclosure needs to be buried. This section of pipe needs to be buried at its original location at the time of development. A post needs to be put next to the vent pipe below the spring enclosure, and the pile of cut willows outside the spring enclosure needs to be removed.

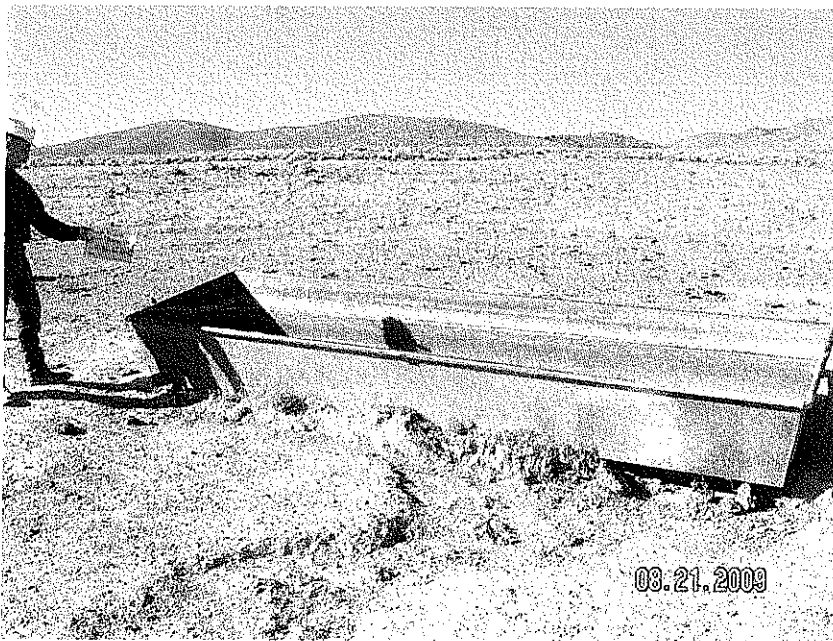
Blue Lead Pipe Line

Trough 3 (needs leveled)

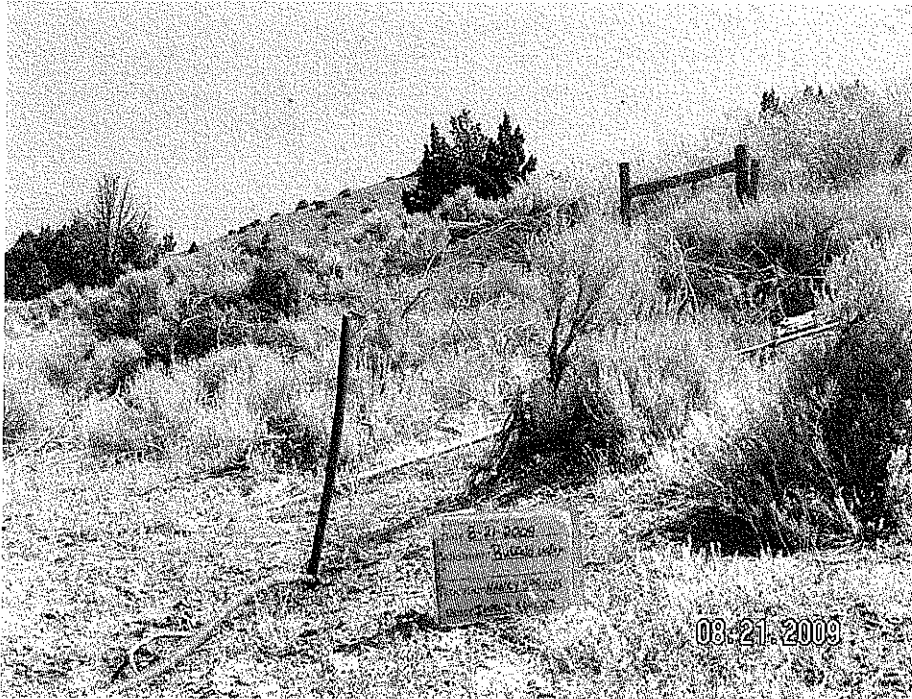
Nancy Spring

Need to bury pipe and put a post by vent pipe

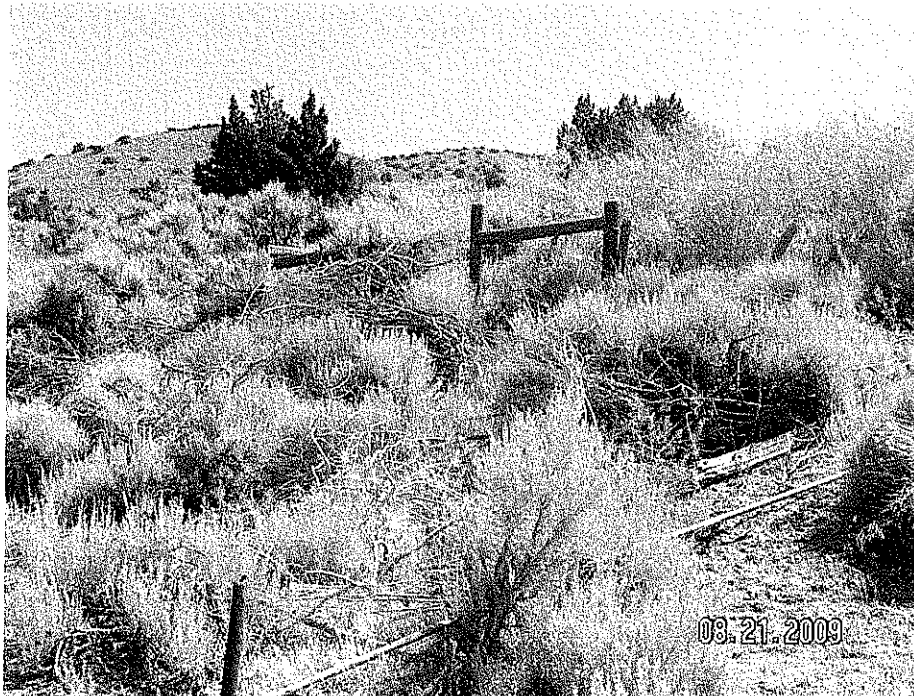
Need to remove cut willows piled below spring enclosure

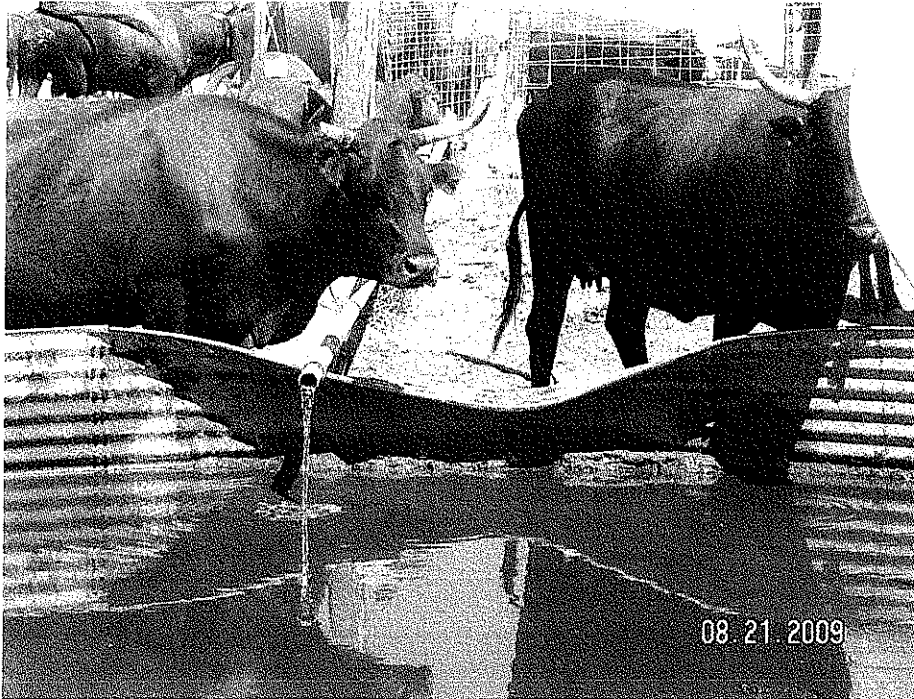
McCoy Well

Need to repair trough

4. McCoy Well: The trough needs to be repaired and a bird ladder installed. The old wind mill and miscellaneous scrap lumber, wire, etc. needs to be removed.
5. Gravel Pit Spring: The trough needs to be moved back to its original location and a bird ladder installed.
6. Cow Creek Pipeline: The overflow on Trough 2 is currently plumbed into the main line. In order to receive a passing inspection the overflow needs to be re-plumbed to flow into the overflow pond.

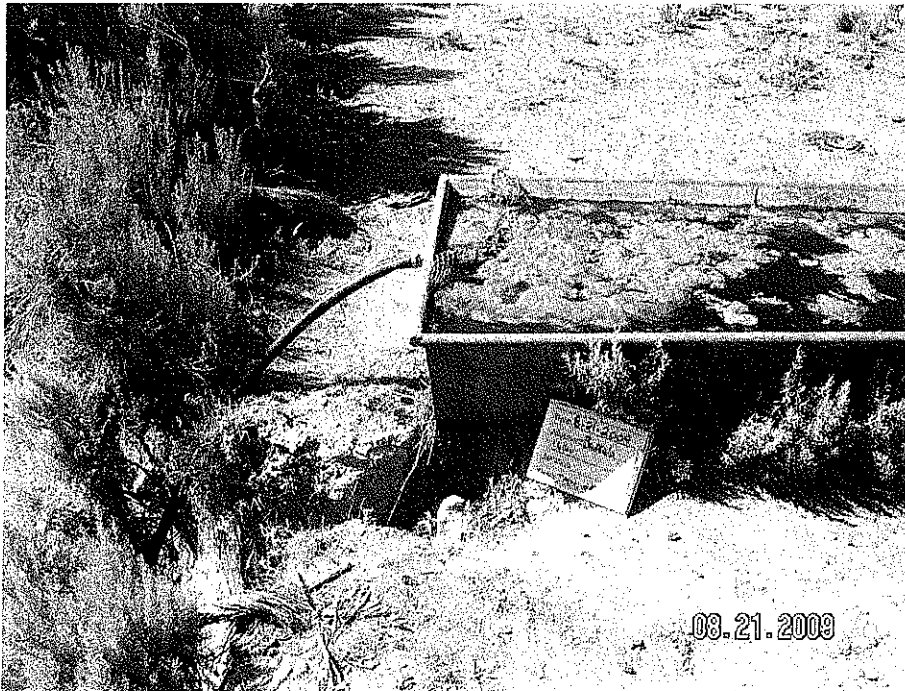
Gravel Pit Spring

Need to move trough away from stream bank, back to its original location
